Are asymmetric metal markings on the cone surface of ceramic femoral heads an indication of entrapped debris?

Sebastian Valet^{1*}, Bernhard Weisse¹, Jakob Kuebler², Martin Zimmermann³, Christian Affolter¹ and Giovanni Pietro Terrasi¹

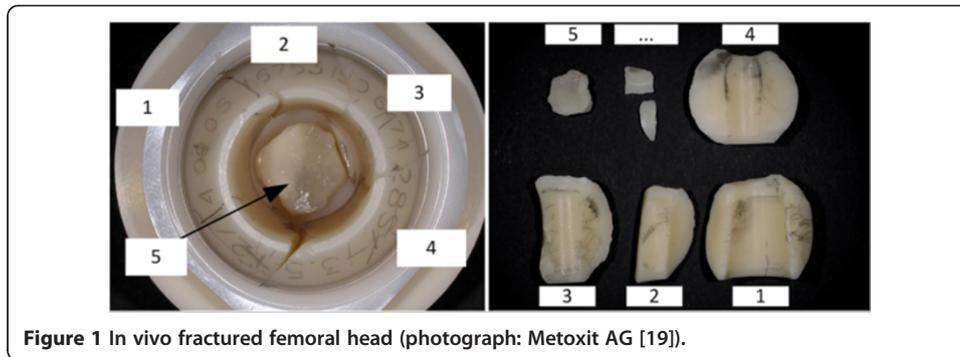
Analyses of in vivo fractured ball heads have repeatedly shown asymmetric metal markings on the conical surface of the ceramic fragments [15-18]. Figure 1 shows a typical case of an in vivo fracture of an alumina ceramic head [19]. Inspection of the fractured alumina ball heads typically showed asymmetric distribution of metal marking, resulting, presumably, from the motion in the taper fit interface between the titanium alloy stem and ceramic head prior to fracture (called primary metal marking). Additional metal markings (called secondary metal marking) can be caused by movement between fractured fragments and the stem as they are present on the fragments. Metal markings along fracture edges also appeared on fragments (Figure 1).

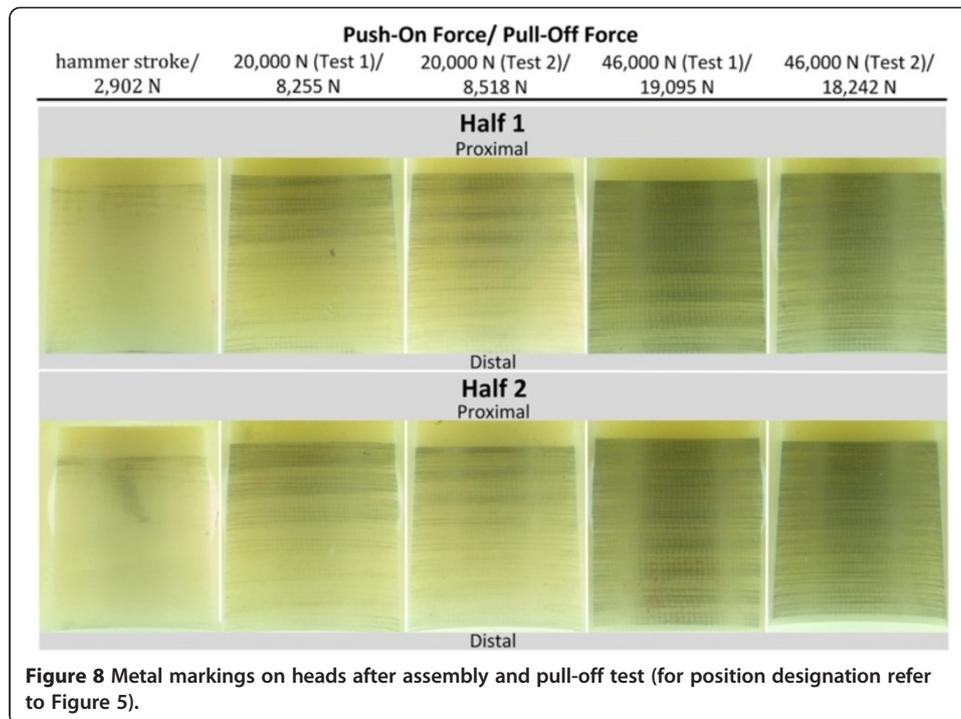
The load–displacement behaviour of all tests showed an almost linear character up to a push-on force of 20 kN and 46 kN. With an increase of the push-on force of 230%, the mean force required to disassemble the heads also increased by 223% (20 kN: $n = 2$, mean = 8,387 N, range = 263 N; 46 kN: $n = 2$, mean = 18,669 N, range = 853 N). The ratio between pull-off force and maximum push-on force was in the range of 0.40-0.43 ($n = 4$, mean value = 0.41, range = 0.03, SD = 0.01). The mean force that was measured during pull-off of ball heads that had been assembled with one hammer stroke was 1,510 N ($n = 3$, range = 863 N, SD = 293 N). Images of the conical surface of the tested heads are shown in Figure 8. The measured distance d_{GAP} of heads assembled with a load of 20 kN was in a range of 2.3-2.4 mm. On heads assembled with a load of 46 kN, the measured distance d_{GAP} was in a range of 2.1-2.2 mm.

The analysis of the images allowed the following observations to be made:

- **Metal marking characteristics:** The metal marking appeared in a pattern of lines that resulted from manufacturing ridges on the surface of the titanium-taper.

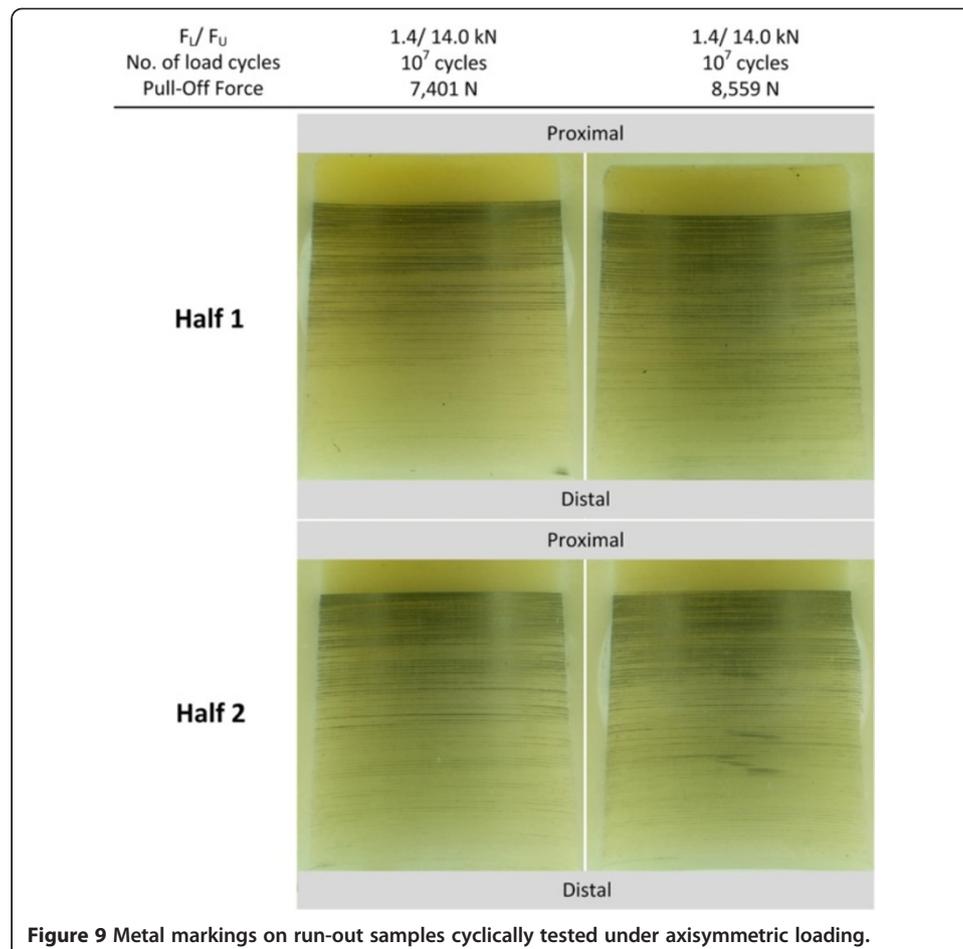
Both tested ball heads passed the cyclic test at an upper compressive load F_U of 14 kN without fracture. No signs of failure were visible on the outside of the head. Both samples were pulled off of the titanium-alloy cone in order to quantify the remaining taper fit stability. A mean pull-off force of 8,215 N was required to pull off the heads after the end of the cyclic tests. This represents a ratio between pull-off and maximum push-on load of 0.35 ($n = 2$, range: 0.02), which is slightly less than the ratio measured in static assembly tests. The remaining metal markings on the tested ball heads are shown in Figure 9. The measured distance d_{GAP} was in a range of 2.4-2.5 mm.

- **Distribution of metal marking:** an axisymmetric distribution of metallic marking (TiAl6V4) is present along the circumferential direction for both cyclically tested samples. A clear gradient of metal marking is present in the direction of the taper axis. Most metal markings appeared in the proximal area of the cone, whereas slight metal markings are visible at the distal part of the bore hole. The conical surface exhibited similar distribution of metal marking when compared to the samples that had been statically tested.

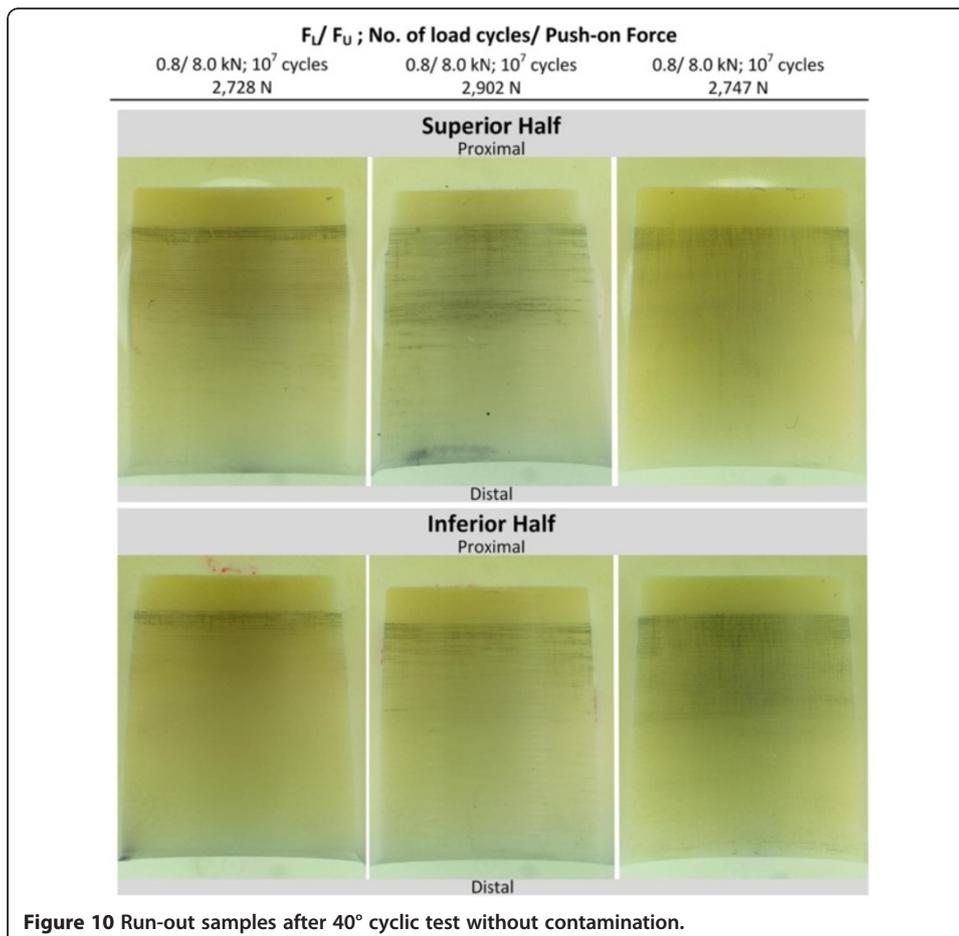
Figure 10 shows the metal marking that occurred under asymmetric loading. Both samples were loaded for 10 million load cycles at a lower compressive cyclic load of 8 kN. A mean force of 2,792 N (n = 3, range: 174 N) was required to pull-off the heads after the cyclic test. The measured distance d_{GAP} was in a range of 2.2-2.5 mm.

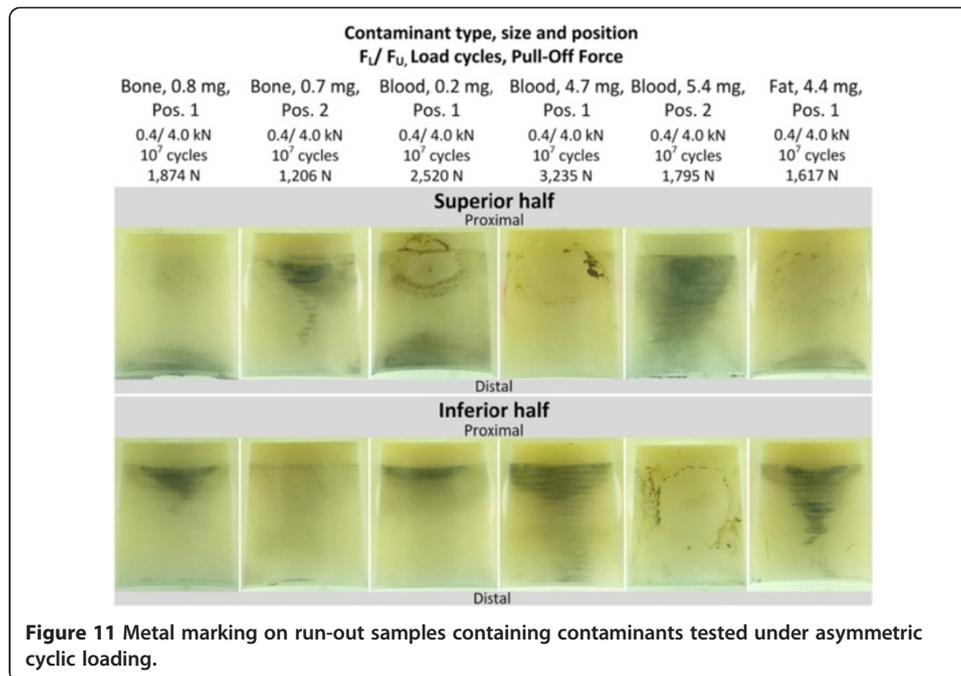
Figure 11 shows metallic marking on heads tested in a 40° configuration that had passed the run-out criterion (10 million load cycles) without failure. The average value of the force required to pull-off the heads from the differently contaminated taper was 2,041 N (n = 6, SD = 721 N, range = 2,029 N). The measured distance d_{GAP} was in a range of 2.5-2.7 mm.

Analysis of the conical surface of all heads with contaminants yields the following observations:

- **Distribution of metal marking in circumferential direction:** A strongly asymmetric distribution of metal markings is present along the circumferential direction.
- **Distribution of metal marking along taper axis:** Two regions of increased metal markings are present. Most intense marking appear in the proximal area at the opposite cone half of the contaminant, whereas slight markings are visible in the distal area on the superior and inferior side of the head.
- **Influence of contaminant position:** If the contaminant was placed on the opposite side of the cone (from superior to inferior side) it did not significantly change the degree and distribution of the resulting metal marking.

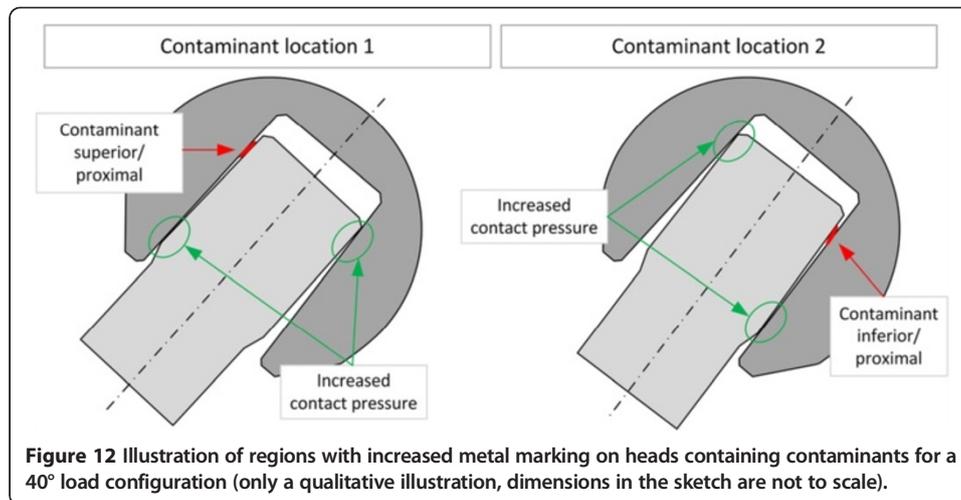
The presence of a contaminant introduces an eccentricity and misalignment between the taper axes of the stem and the conical hollow of the ball head. Thus, additional contact pressure on the distal end on one side causes a tipping of the ball, which then creates an increased contact pressure at the proximal end but on the opposite side.

Figure 12 qualitatively shows how the taper interface is affected by the presence of a contaminant. The illustrated schematic shows the taper-interface fit in a cross-sectional view along the cone axis and in the plane of the applied test load and contaminant position (Figure 12). Residuals concentrated on one position and side of the stem surface will, if not completely compressed, result in a slight tilt of the stem-cone against the cone of the femoral head. This situation increases local contact stresses in two regions as depicted in the sketch (Figure 12). As metal markings were predominant in the regions of increased contact stresses, it can be proposed that they were caused by the increase in local contact pressure in these regions.

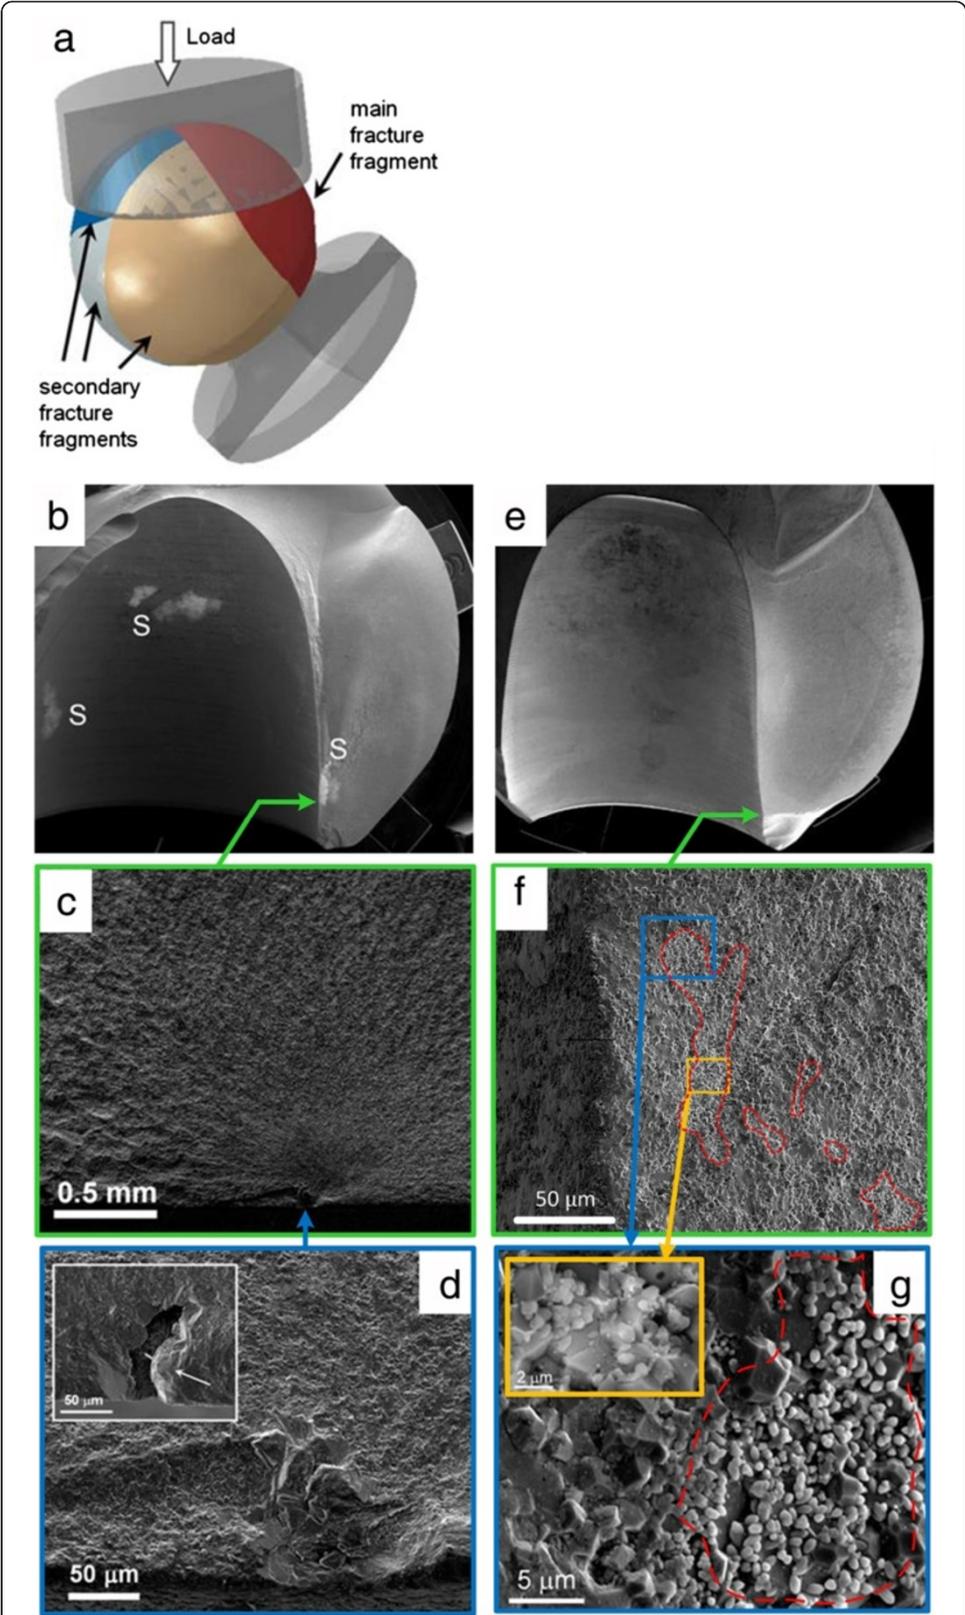
Figure 14 (See legend on next page.)

Seven of the total 18 femoral heads tested failed before reaching the test stop criterion of 10^7 cycles. Four of those seven heads (test no. 5, 7, 14 and 15) were selected for a first failure analysis which revealed that the heads had a common failure pattern. Independent of the contamination position (1 or 2) between stem and head bore and as a result of the loading configuration a main fracture fragment with spherical calotte shape was detached from the superior half of the heads (Figure 13a). For a more in-depth failure analysis the femoral heads with the lowest number of load cycles till failure (test no. 15, $<10^3$ cycles) and the one with the highest number (test no. 5, $3.28 \cdot 10^6$ cycles) were selected, Figure 14. Figure 13b and Figure 13e show the main fracture fragments of the two heads with arrows marking the fracture origins. On the main fracture fragment of test no. 15 two white spots could be seen in the bore and one covering the failure origin. The spots originated most likely from the salt in the Ringer-solution in which the tests were conducted at a temperature of 37°C and could be removed easily with lukewarm water. That femoral head failed from a large pore connected to a granule which had not been destroyed during pressing of the ceramic green body, Figure 13c and Figure 13d. The other head (test no. 5) failed from a porous region, Figure 13f. In the porous region loose, slightly necked or aggregated grains with a diameter in the range of 0.5 to 1 μm could be found, Figure 13g. In a back scattered (BS) electron microscope image almost no difference in the grey levels of the grains and the surrounding Al_2O_3 ceramic can be seen, insert in Figure 13g.

With the failure relevant defect size (depth) in test no. 15 which is, based on the fractographic images, roughly $a = 120 \mu\text{m}$ and the Griffith equation [34] it is possible to estimate that the relevant stress σ at failure had been about in the range of 280 MPa. For test no. 5 it was not possible to estimate a relevant failure size fractographically.

Fracture of samples at the beginning of the cyclic testing may be attributed to either static overloading during the increase of the cyclic test load or to low cycle fatigue due to subcritical crack-growth. In either case stress concentration induced by the contaminants are likely to have contributed to the failure. Asymmetric metallic traces found on the fragments of the in-vivo fracture as well as of the ball head fracture under asymmetric test conditions are an indication of an asymmetric contact pressure distribution. This asymmetry can be caused by the presence of contaminants resulting in locally increased contact stresses. In this study, all tested heads containing different types and sizes of contaminants exhibited significant asymmetric distribution of metallic marks on the conical surface. Contaminants such as bone chips, soft tissue or blood entrapped in the taper fit were reported to lower the fracture load in a test according to ISO 7206-10 by up to 90% [9,11]. The types of fracture observed in the failed heads of the present study were similar to the typical bore failure as reported for a static axisymmetric burst test [1].

Therefore, we suppose that the failure of the ball heads was caused by an increase of the maximum stresses in the ball head due to the presence of the contaminants. Additional analysis would be needed to quantify the increase of maximum stress if a contaminant is entrapped in the taper fit. This analysis may be conducted in a separate study.

Figure 14 Fratographic analysis. **a)** General fracture behaviour of ball heads failing before reaching 107 fatigue cycles. **b, c, d)** Test Nr. 15 (<103 cycles) and **e, f, g)** Test Nr. 5 (3.28*106 cycles) **b, e)** Main fracture fragment (fish-eye mode). Arrow marks fracture origin and S salt scales. **c)** Arrow marks fracture origin. **d)** Fracture origin magnified. Insert: opposite fracture surface. Arrow marks a granule, attached to large pore. The granule had not been destroyed during pressing the green body. **f)** Fracture origin magnified (circular line marks area in which porous regions were found). **g)** Magnified area showing a fine grained contamination. Insert: Magnified area BS shown in BSE mode.
