Are asymmetric metal markings on the cone surface of ceramic femoral heads an indication of entrapped debris?

Sebastian Valet^{1*}, Bernhard Weisse¹, Jakob Kuebler², Martin Zimmermann³, Christian Affolter¹ and Giovanni Pietro Terrasi¹

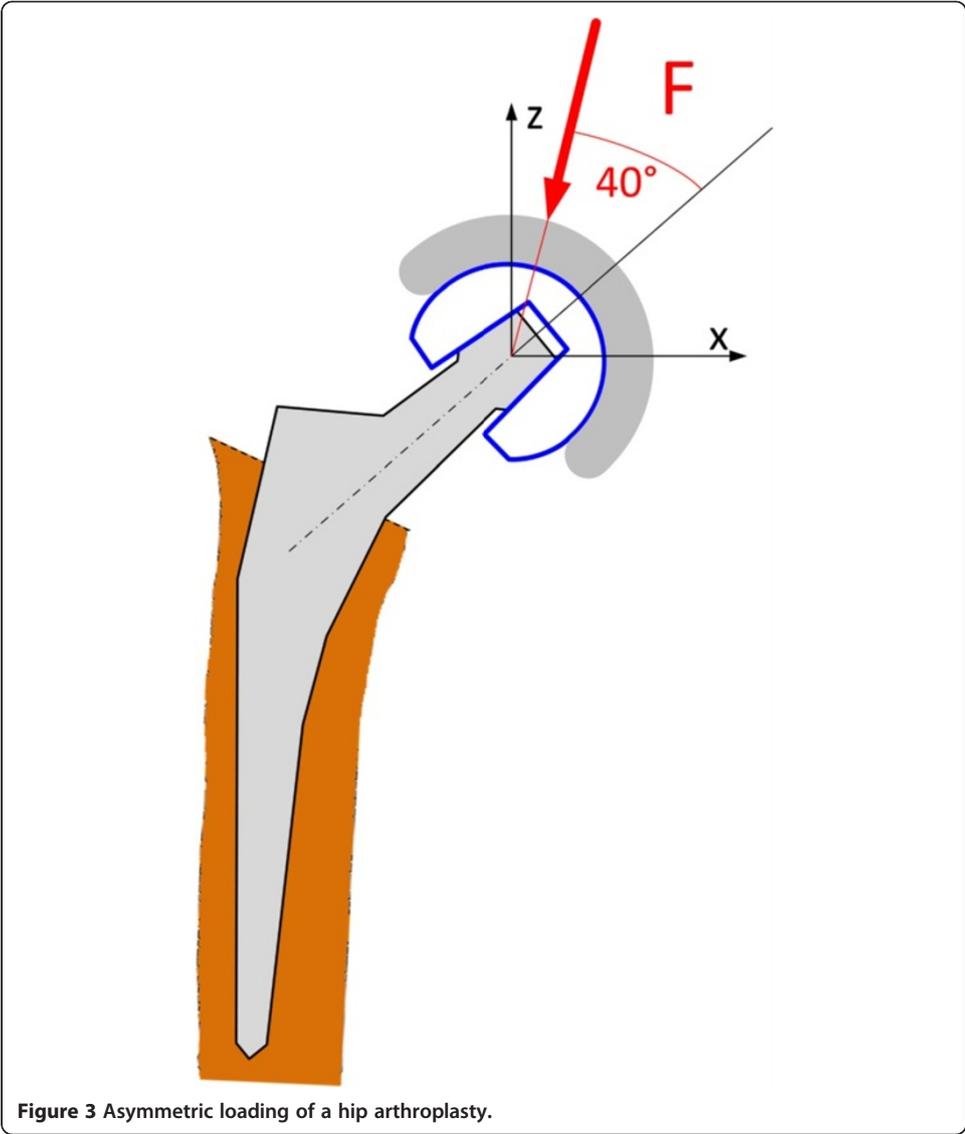
Figure 3 Asymmetric loading of a hip arthroplasty.

Cyclic loading tests were carried out in an axisymmetric and asymmetric load configuration using two different test setups (Figure 4). The angle between the load applied onto the ball and the centre line of the taper fit (femoral head-neck axis) was chosen as a realistic mean value to represent asymmetric loading in the daily life activities of a hip joint. The physiological condition that results in asymmetric loading of the taper-fit is schematically depicted in Figure 3.

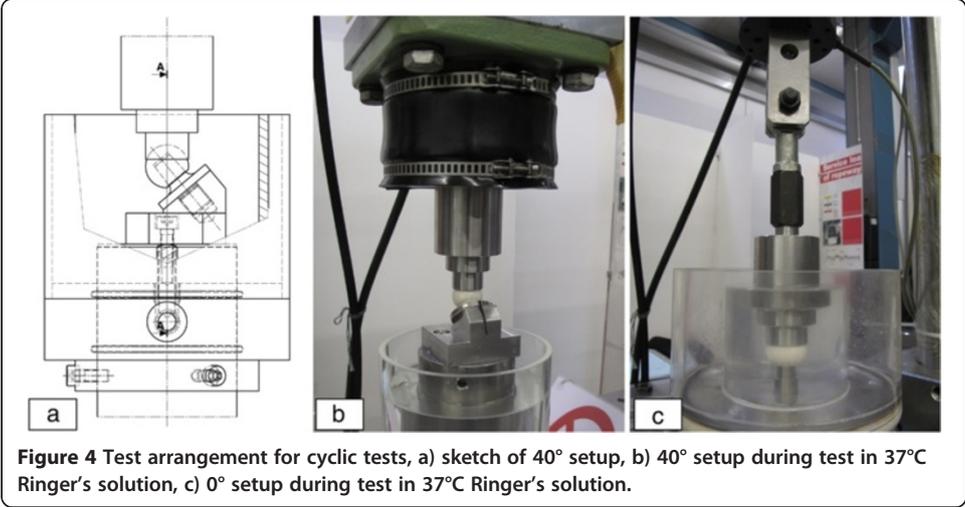
Figure 4 Test arrangement for cyclic tests, a) sketch of 40° setup, b) 40° setup during test in 37°C Ringer's solution, c) 0° setup during test in 37°C Ringer's solution.

A test set-up was built and placed in a servo-hydraulic test machine to determine the influence of the physiological load condition on the metal marking characteristic in the conical bore with and without contaminants (Figure 4). In the cyclic configuration, the load was transmitted to the ball head through a spherical stainless steel cup adapter. A rolling table or ball joint was placed between the load cell and the cup adapter to avoid the transmission of transverse forces onto the sample. The load cell (accuracy class 1, EN ISO 7500-2:2004) was attached to the piston of the load cylinder which was fixed to the cross-head of the test machine. The ball head was mounted on a titanium alloy stem (TiAl6V4, Young's modulus of 122 GPa) that was screwed into a stem holder in

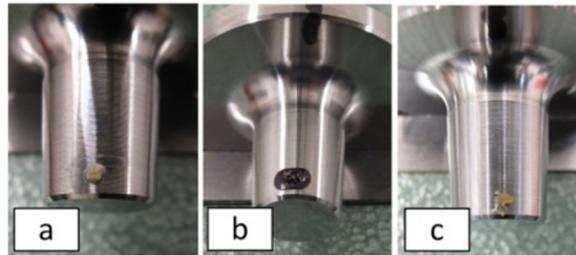
Bone chips and fat were glued with a single component, cold-curing cyanoacrylate adhesive (trade name, HBM Z70; commonly used to apply strain gauges). In our previous study [11], the largest reduction in the fracture load was observed when the contaminants were located at the proximal end of the cone surface (Figure 5). In this study, contaminants were again applied at the proximal end of the cone surface, 2 mm from the edge of the proximal end facing in either superior or inferior direction (refer to Figure 5 for orientation, Figure 6 shows contaminants applied on the stem surface). Any position of interest in the conical surface has been designated by two axes in a plane parallel to the coronal plane (A/P). The position was separated into four segments of interest: superior/distal, superior/proximal, inferior/distal, inferior/proximal. The gap between the proximal end of the stem and the bottom of the bore hole was designated as d_{GAP} .

Figure 6 Application of contaminants on the top position of the stem replacement. (a) bone chip – 0.8 mg, (b): human blood – 4.7 mg, (c): bovine fat - 1 mg.

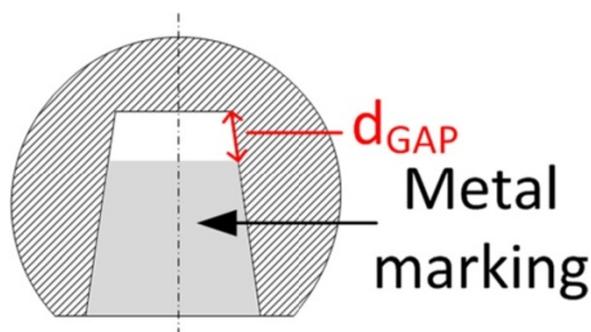
that corresponds to the proximal end of the stem. The distance was measured along the cone edge in the cross-sectional view and designated as d_{GAP} (Figure 7). The colour of the ceramic material shown in the images does not represent the original colour of the material. Settings were chosen in order to assure good contrast of the metal marking.

Figure 7 Illustration of measurement position.

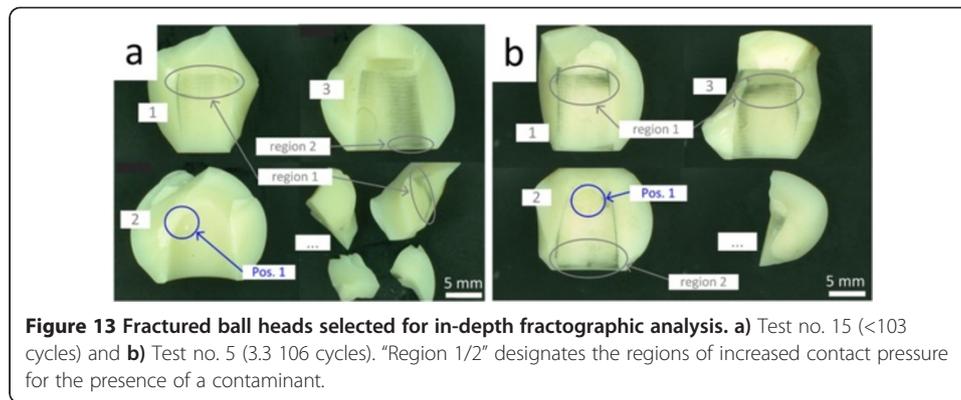
Seven of the total 18 femoral heads tested failed before reaching the test stop criterion of 10^7 cycles. Four of those seven heads (test no. 5, 7, 14 and 15) were selected for a first failure analysis which revealed that the heads had a common failure pattern. Independent of the contamination position (1 or 2) between stem and head bore and as a result of the loading configuration a main fracture fragment with spherical calotte shape was detached from the superior half of the heads (Figure 13a). For a more in-depth failure analysis the femoral heads with the lowest number of load cycles till failure (test no. 15, $<10^3$ cycles) and the one with the highest number (test no. 5, $3.28 \cdot 10^6$ cycles) were selected, Figure 14. Figure 13b and Figure 13e show the main fracture fragments of the two heads with arrows marking the fracture origins. On the main fracture fragment of test no. 15 two white spots could be seen in the bore and one covering the failure origin. The spots originated most likely from the salt in the Ringer-solution in which the tests were conducted at a temperature of 37°C and could be removed easily with lukewarm water. That femoral head failed from a large pore connected to a granule which had not been destroyed during pressing of the ceramic green body, Figure 13c and Figure 13d. The other head (test no. 5) failed from a porous region, Figure 13f. In the porous region loose, slightly necked or aggregated grains with a diameter in the range of 0.5 to 1 μm could be found, Figure 13g. In a back scattered (BS) electron microscope image almost no difference in the grey levels of the grains and the surrounding Al_2O_3 ceramic can be seen, insert in Figure 13g.

Therefore, the grains might be not properly densified Al_2O_3 particles or, more likely fine grained powder from a sintering additive to reduce grain growth, when sintering Al_2O_3 .

With the failure relevant defect size (depth) in test no. 15 which is, based on the fractographic images, roughly $a = 120 \mu\text{m}$ and the Griffith equation [34] it is possible to estimate that the relevant stress σ at failure had been about in the range of 280 MPa. For test no. 5 it was not possible to estimate a relevant failure size fractographically.
